Manhole Inspection Summary

Manhole # **S15G__009MH**

Insp Date: **6/25/08 12:19 PM**

Location Address: **2601 LEXINGTON ST**

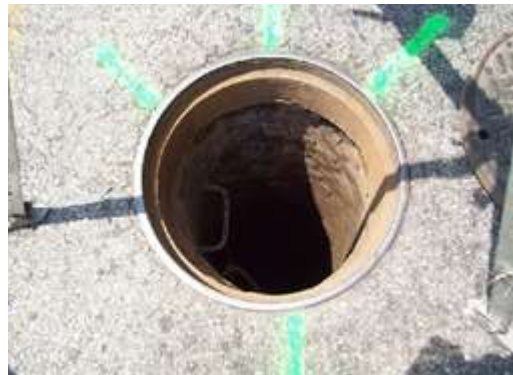
Defect 1

Offset: **2** (in.)

Condition: ☐ Sound ☒ **Cracked** ☐ Root Intrusion ☐ Loose Brick ☐ Deteriorated

CRACKED AT CORBEL AND OFFSET
FRAME

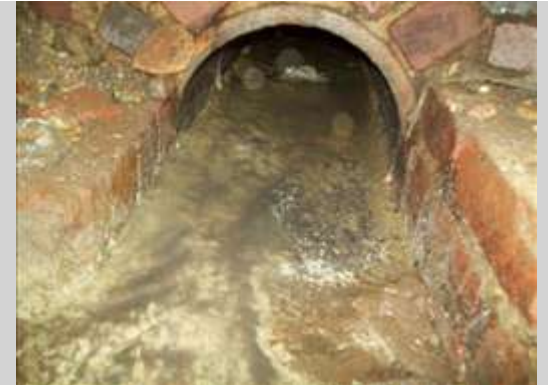
12 O'Clock Outflow

12 in. Circular Gravity Sewer
Pipe Out @ 12 O'Clock

Pipe Height: (in.) Direct
Pipe Material: **Clay** ☐ Pipe Lined
Invert Depth: **26.13** (ft.) Flow Characteristics: **Slow**
Deposits: ☒ None ☐ Mud ☐ Sludge ☐ Debris ☐ Grease
Silt Depth: (in.) Deposits Extent:
Infiltration: **None** Pipe Seal Cond: **Sound**

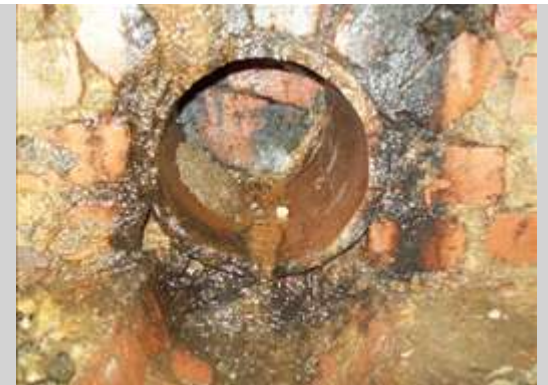
5 O'Clock Inflow

8 in. Circular Gravity Sewer
Pipe In @ 5 O'Clock

Pipe Height: (in.) Direct
Pipe Material: **Clay** ☐ Pipe Lined
Invert Depth: **25.31** (ft.) Flow Characteristics: **None**
Deposits: ☒ None ☐ Mud ☐ Sludge ☐ Debris ☐ Grease
Silt Depth: (in.) Deposits Extent:
Infiltration: **None** Pipe Seal Cond: **Sound**

Connects To: **Stub connection / abandoned**

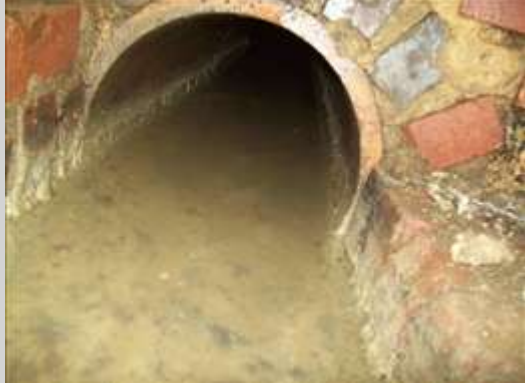
6 O'Clock Inflow

Infiltration: **None** Pipe Seal Cond: **Sound**

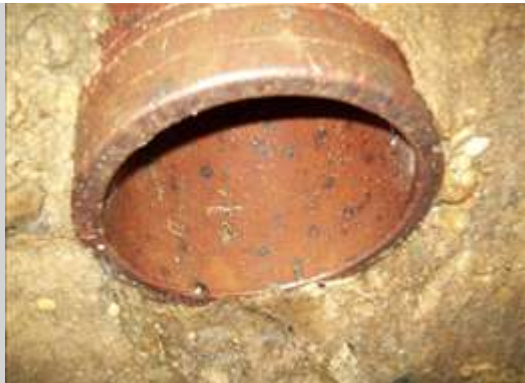
8 O'Clock Inflow

Infiltration: **None** Pipe Seal Cond: **Sound**

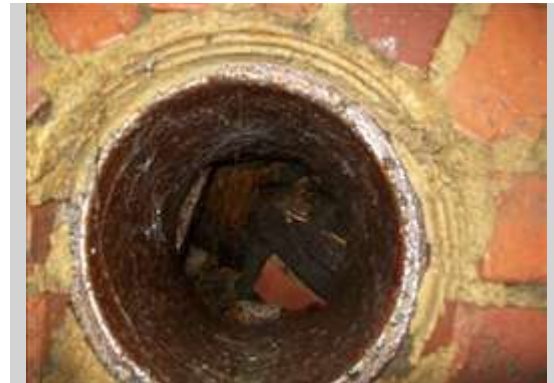
Drop In @ 8 O'Clock

Drop: **Outside Direct**

Drop Condition: **Open**
